REPORT 257

Variable Ship Speed and Usable Life Tests of Nylon-Coated, Surface-Vessel, Bathythermograph Hoisting Cable

L. B. STARK ENGINEERING SERVICES DIVISION

U. S. NAVY ELECTRONICS LABORATORY, SAN DIEGO, CALIFORNIA

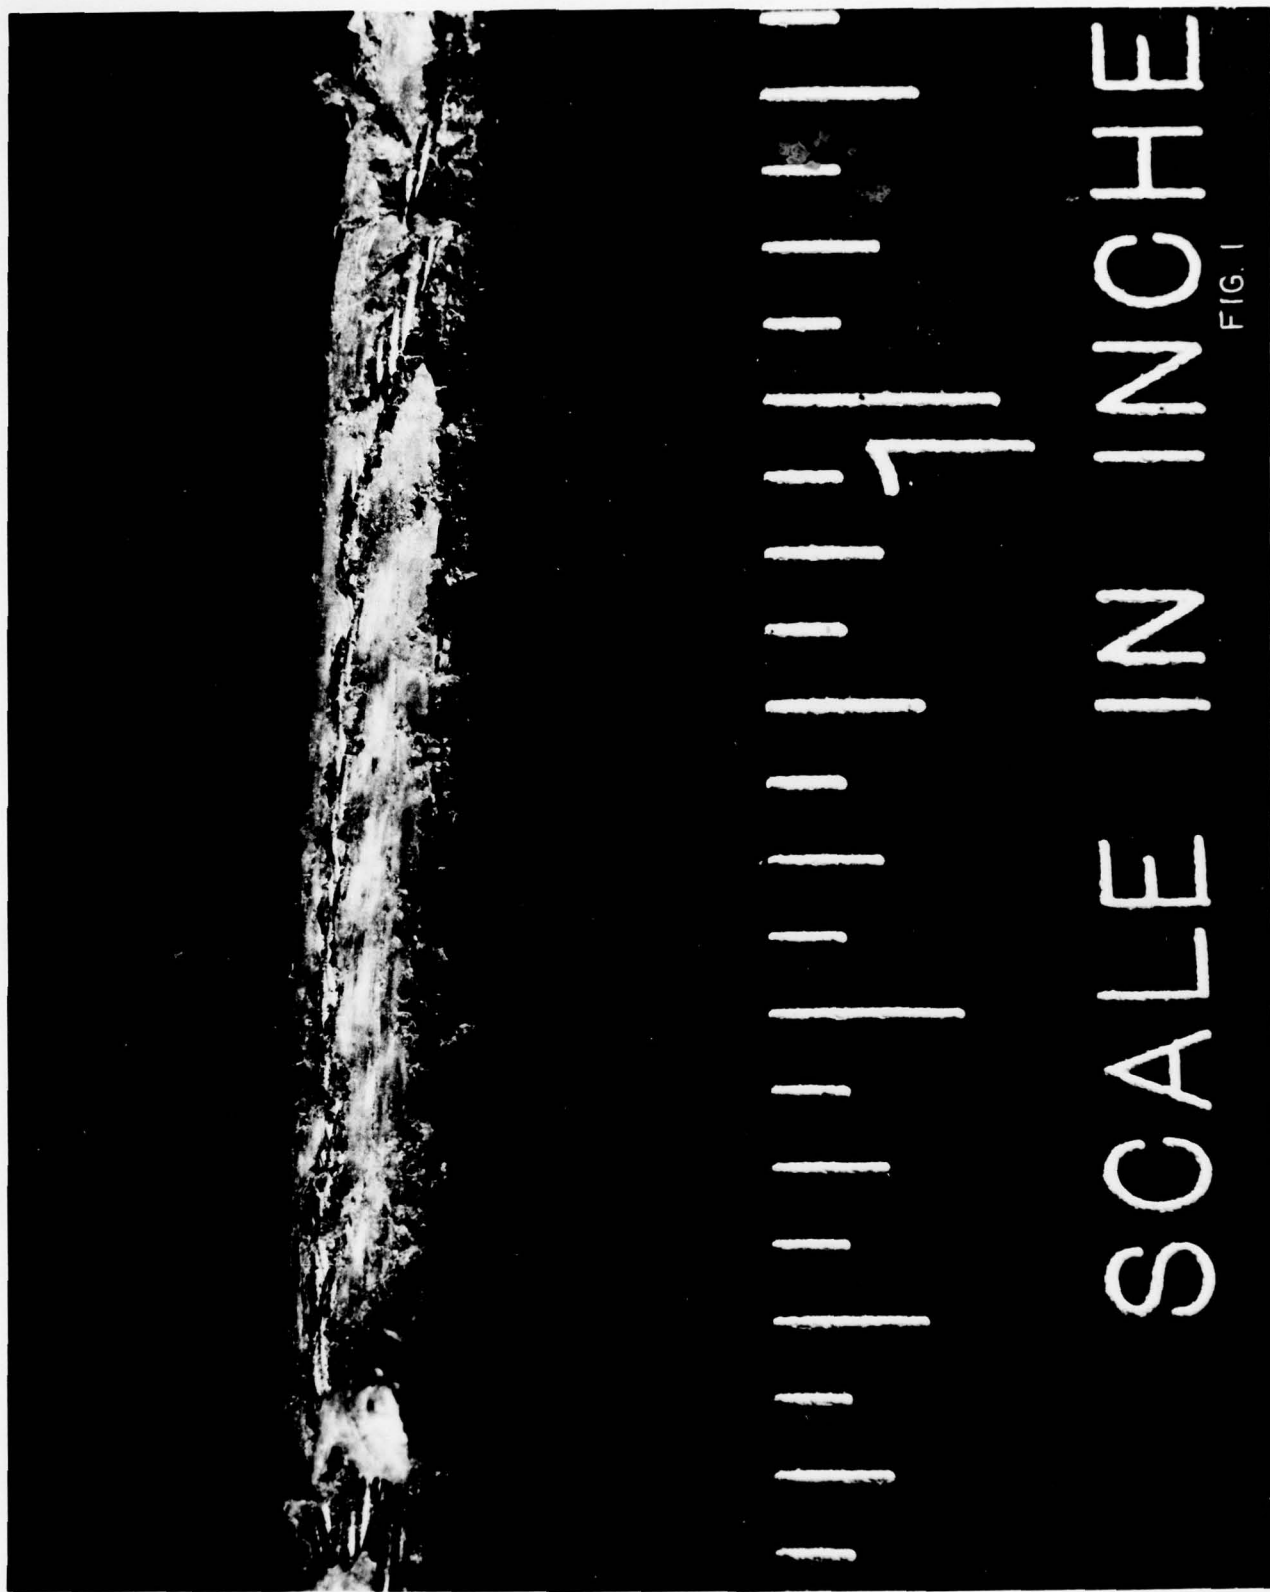
The detailed cable failures are illustrated in figures 1 through 22. Figure 1 is a typical example of a severe tear in the 1/64-in. thick coating of Cable 3. Extreme fraying and distortion is evident at the torn coating edges. The coating failure shown in figure 2 shows the effect of severe abrasion in a section of Cable 3 within 20 feet of the bathythermograph end of the cable. The abrasion caused a longitudinal tear in the 1/64-in. nylon coating as well as secondary spiral cuts and peeling along the edges of the tear.

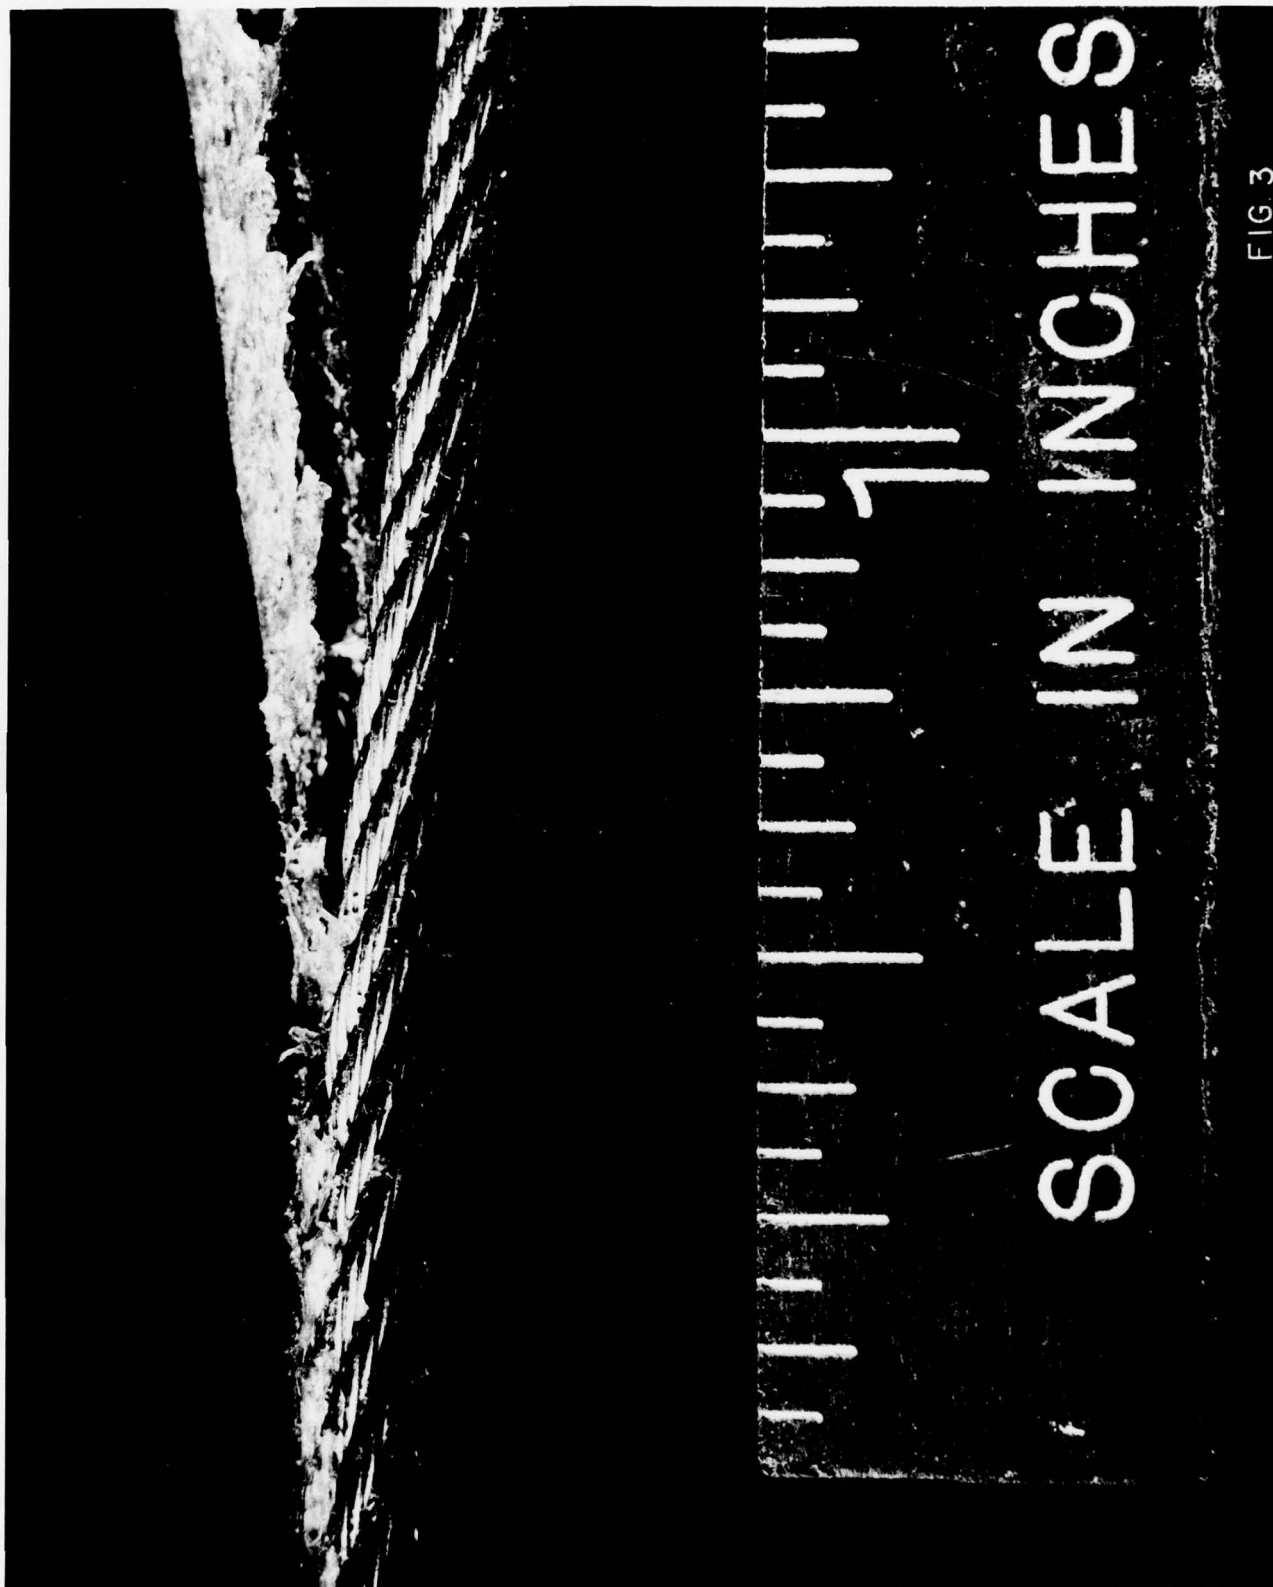
FIG 3

It is important to note the type of coating failure in figure 3, since this type of coating separation occurred in both cables. In this failure the nylon coating split and then pulled completely away from the wire core. This particular peeled area was in Cable 3, approximately 10 feet from the bathythermograph end. The 20-foot section closest to the end of the cable and containing this failure was severed from the cable after 764 lowerings. Figures 4 and 5 are illustrative of severe abrasion most likely due to edge rubbing on the sheave. These damage areas were both in the same 20-foot section of Cable 3 that contained the

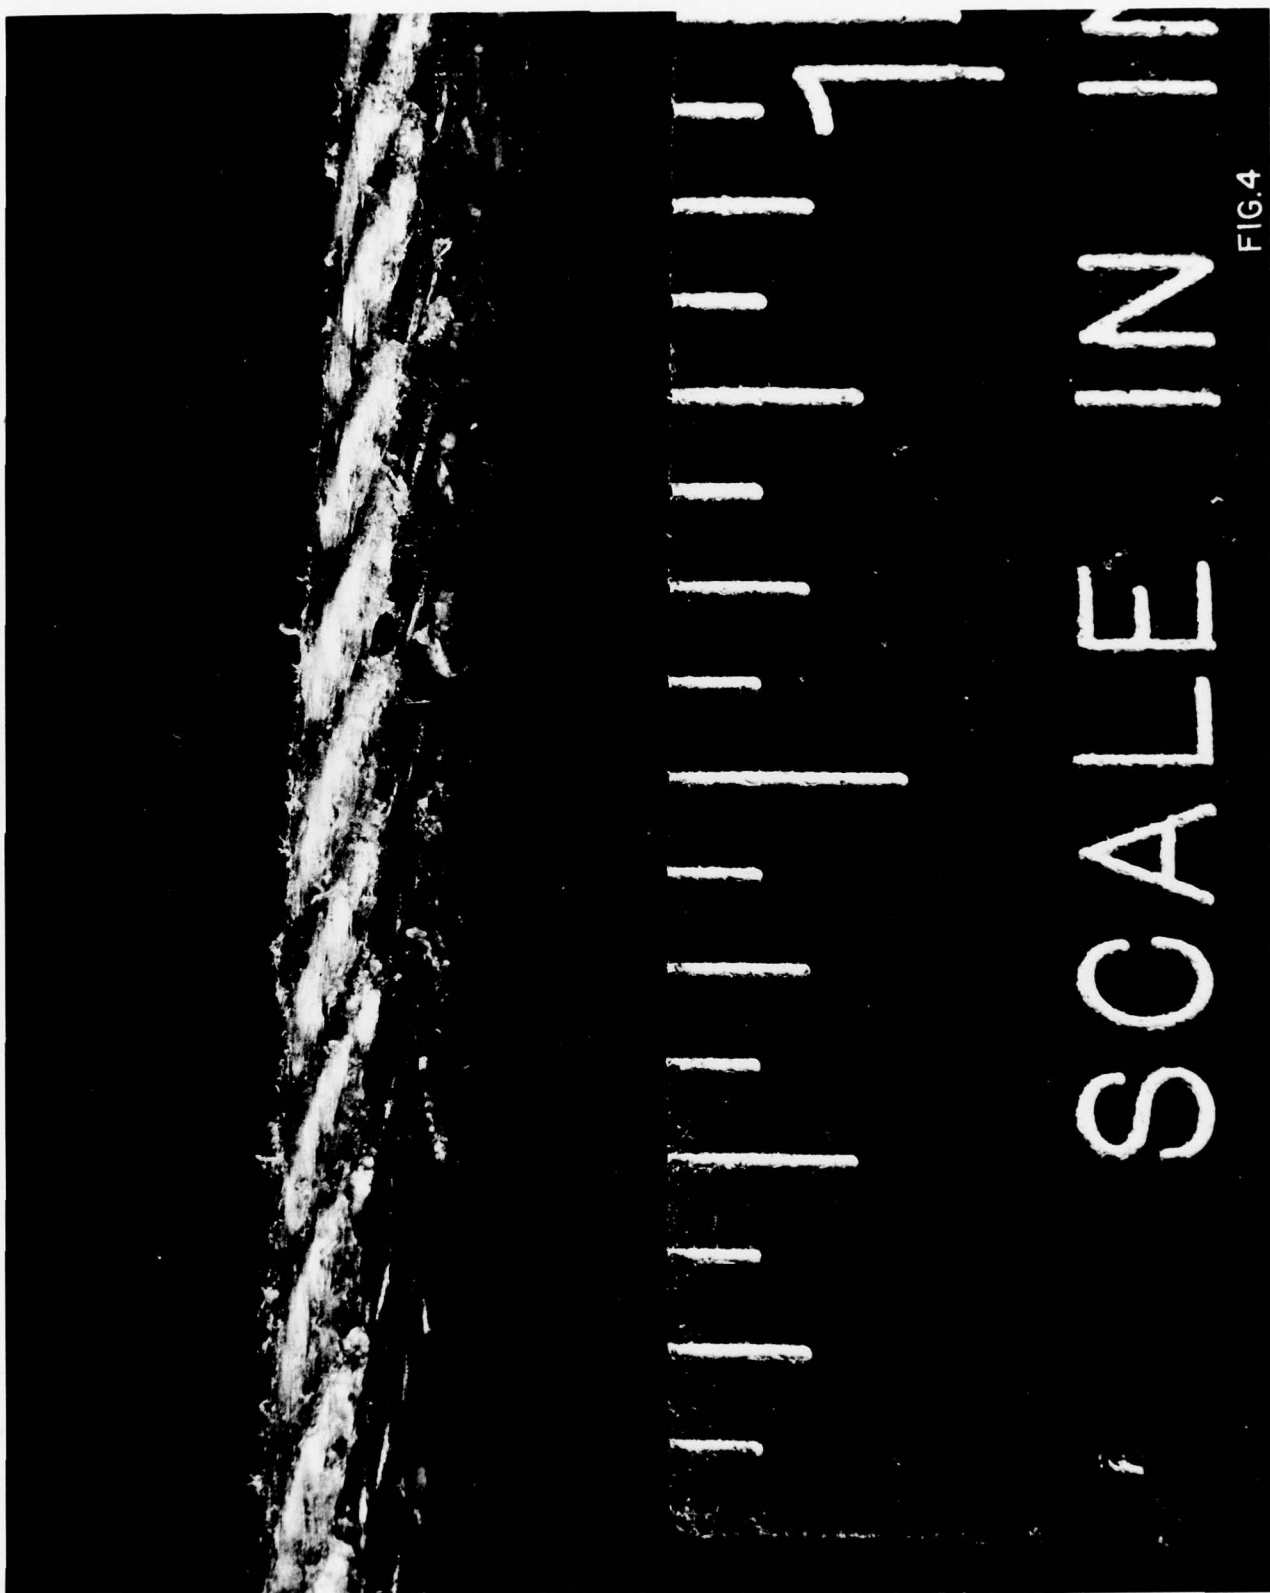
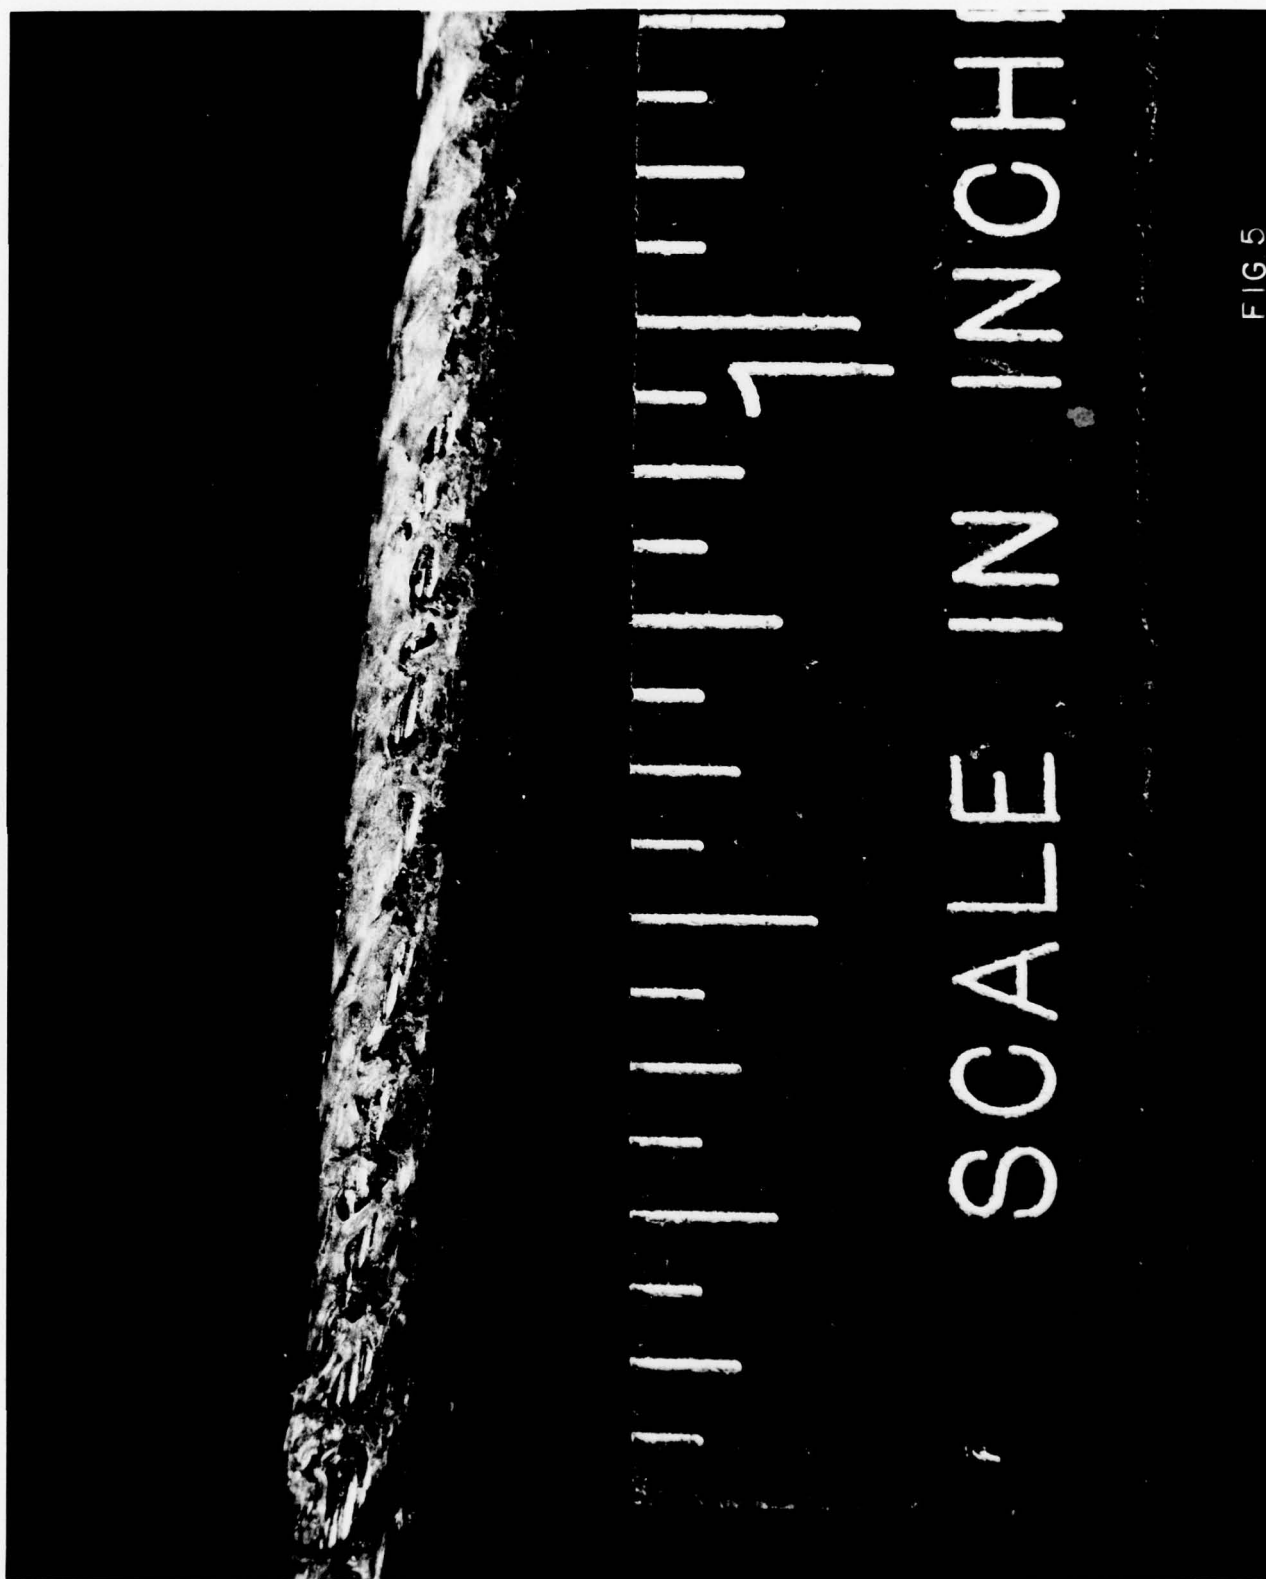
FIG 5

failure shown in figure 3. These photographs clearly show the varied damage which led to the removal of the defective portion of the cable, after which 300 more lowerings were made with the remainder prior to the determination that it was no longer usable.

(3) In order to utilize to a fuller extent the desirable properties of nylon-coated bathythermograph lowering cables, an investigation of sheave materials should be authorized and carried out, in order to find methods to lower abrasive damage to the nylon coatings that occur through sheave contact factors. The feasibility of using molded, or molded and finish-machined, nylon sheaves should be determined as an integral part of such an investigation.

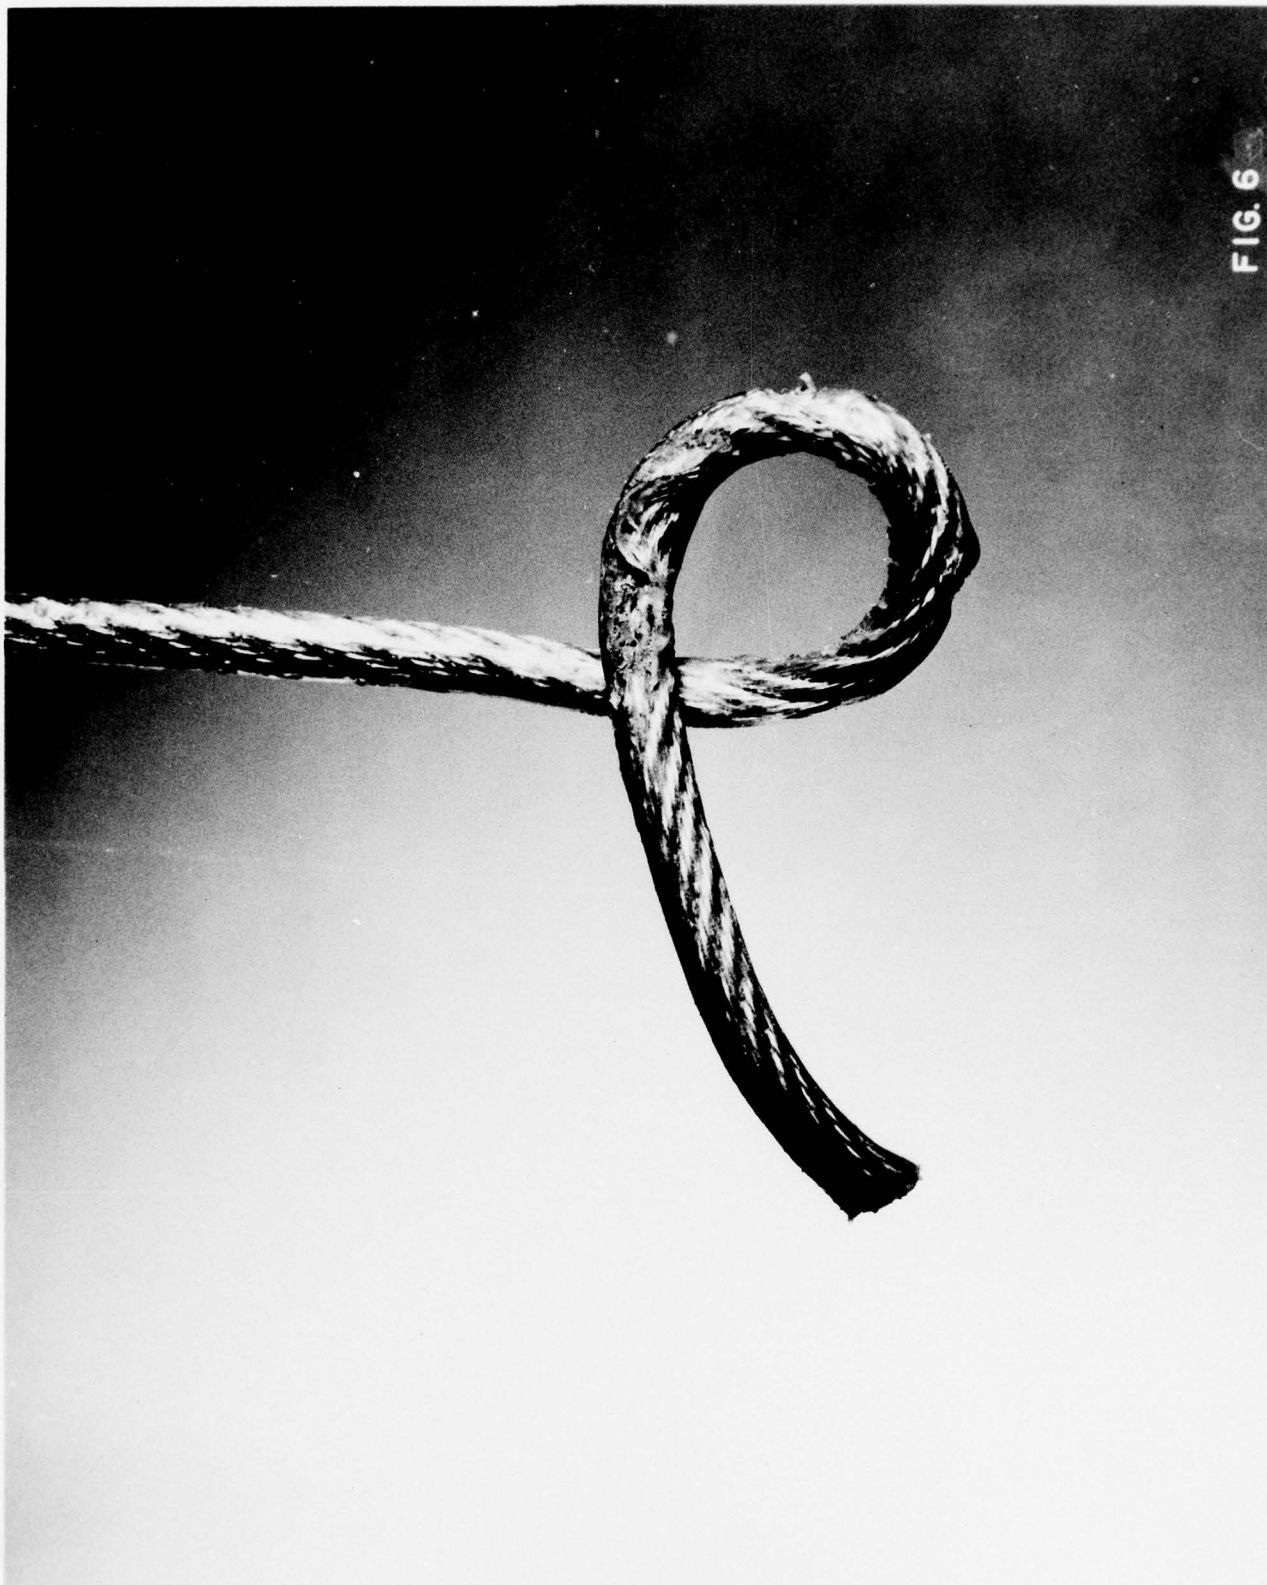
The cable section that appears in figure 6 shows the coating failure resulting at the point where the cable is attached to the bathythermograph shackle. Localized cuts and peeling of the 1/64-in. coating of Cable 3 are typical of the failures caused by this type of cable juncture. The severe longitudinal distortion leading to a transverse "pile-up" of the 1/64-in. nylon coating is shown in different stages of severity in figures 7 and 8. This type of failure occurred at numerous points where small kinks were found in Cable 3. It is quite noticeable that knife-like transverse cracks resulted in the coating, penetrating to the wire core and creating areas where localized corrosive attack would be accelerated.

(5) Danco Sealer No. 4 (manufactured by the Danielson Manufacturing Company, Danielson, Connecticut), or equivalent, should be used on all cable terminations. If such a sealer had been available during this testing program, it is most probable that the fraying of the coating near cable terminations and subsequent wire-core corrosion could have been prevented.

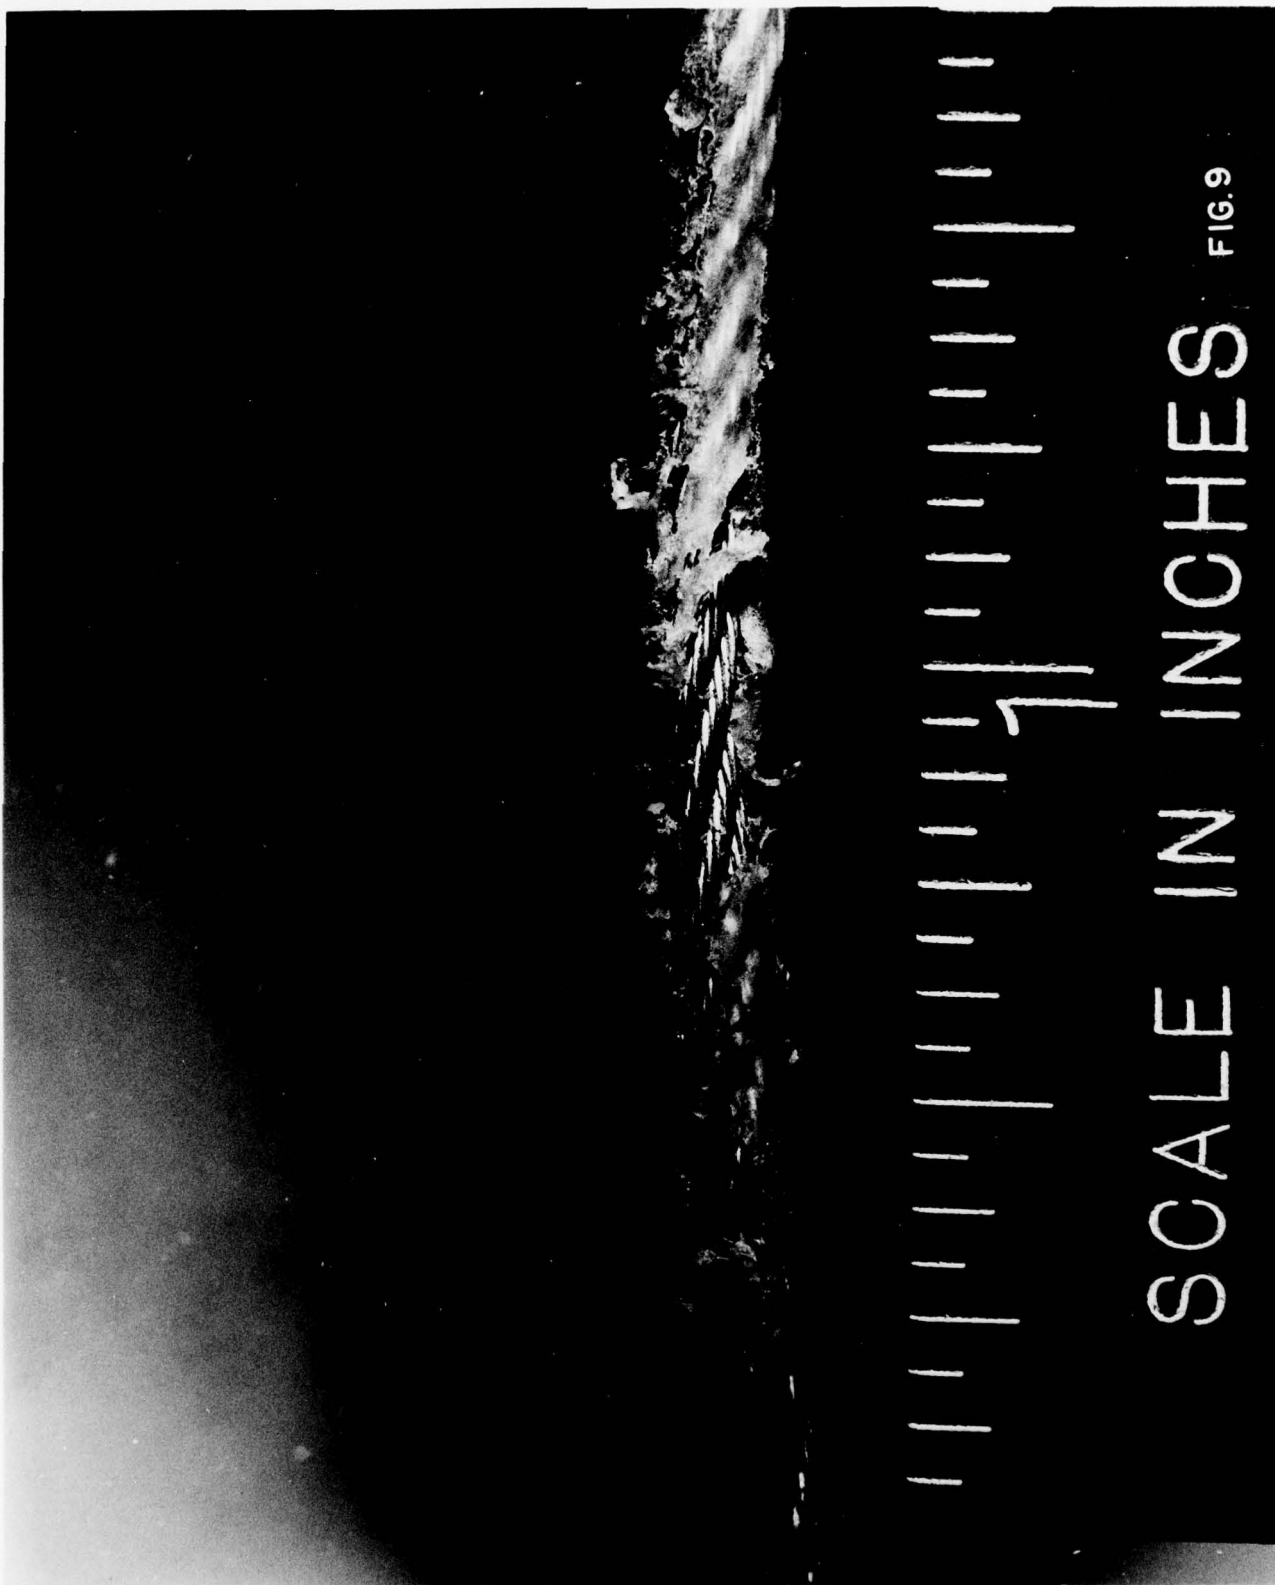
FIG.9

The severely torn and frayed coating section shown in figure 9 is indicative of failure conditions consisting primarily of abrasion (most probably on the sheave sides) and torsion. The spiral tears appearing in the center of the photograph are characteristic of this condition. The failure sections illustrated by figures 10 and 11 are quite distinct from the previous failures shown. These failures occurred in the 1/64-in. nylon coating of Cable 3 and are solely transverse cracks, a large number of them being of sufficient severity to cut down to the wire core. The primary cause of this type of failure is a severe kink. This indicates that kinking of the severity shown is very damaging to such thin nylon coatings and leads to cracks which would cause subsequent peeling and splitting off of the coating from the wire core.

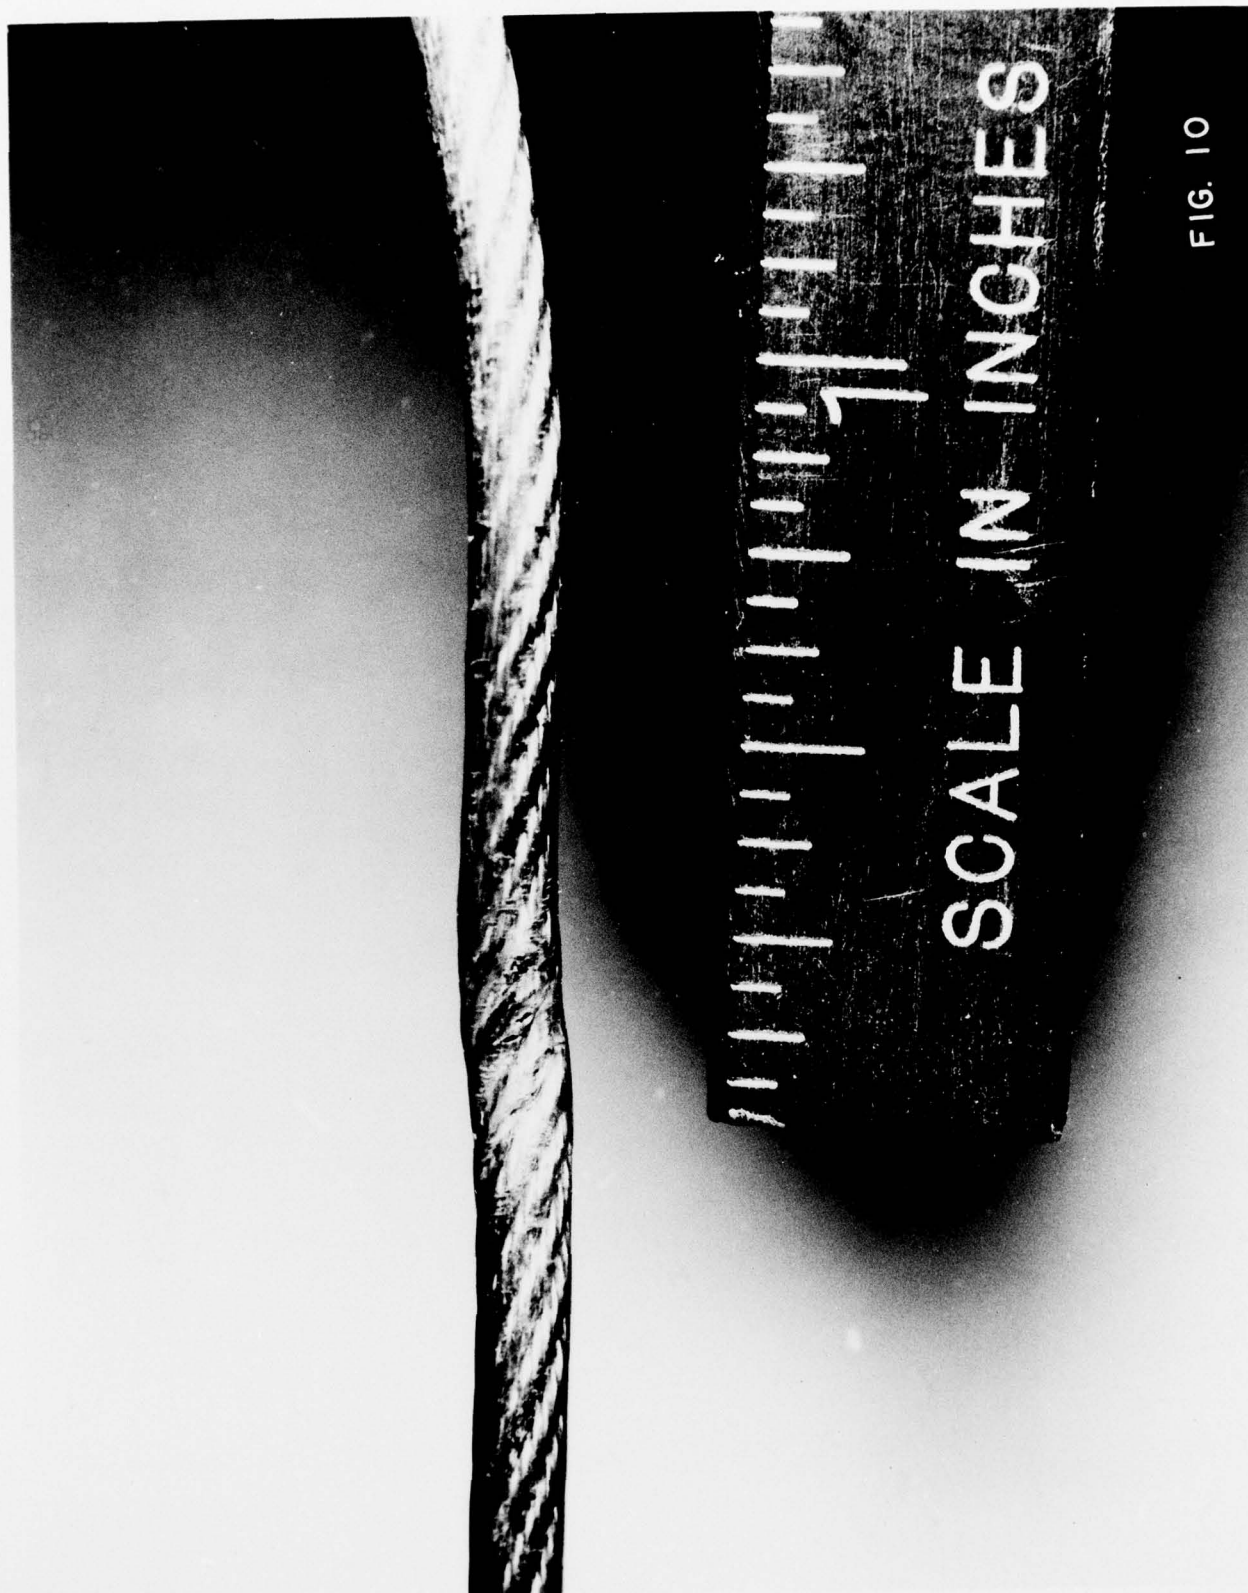
FIG. 10

end. The results of moderate to sharp kinks over short lineal distances on Cable 2 are well illustrated by the coating failures shown in figure 22. It is evident that some transverse "pile-up" of the nylon coating results from the severe longitudinal strains caused by the kinks. In general, these transverse points of coating distortion are not nearly as severe in the 1/32-in. nylon coating of Cable 2 (figure 22) as the similar kinking damage in the 1/64-in. nylon coating of Cable 3 (figures 10 and 11).

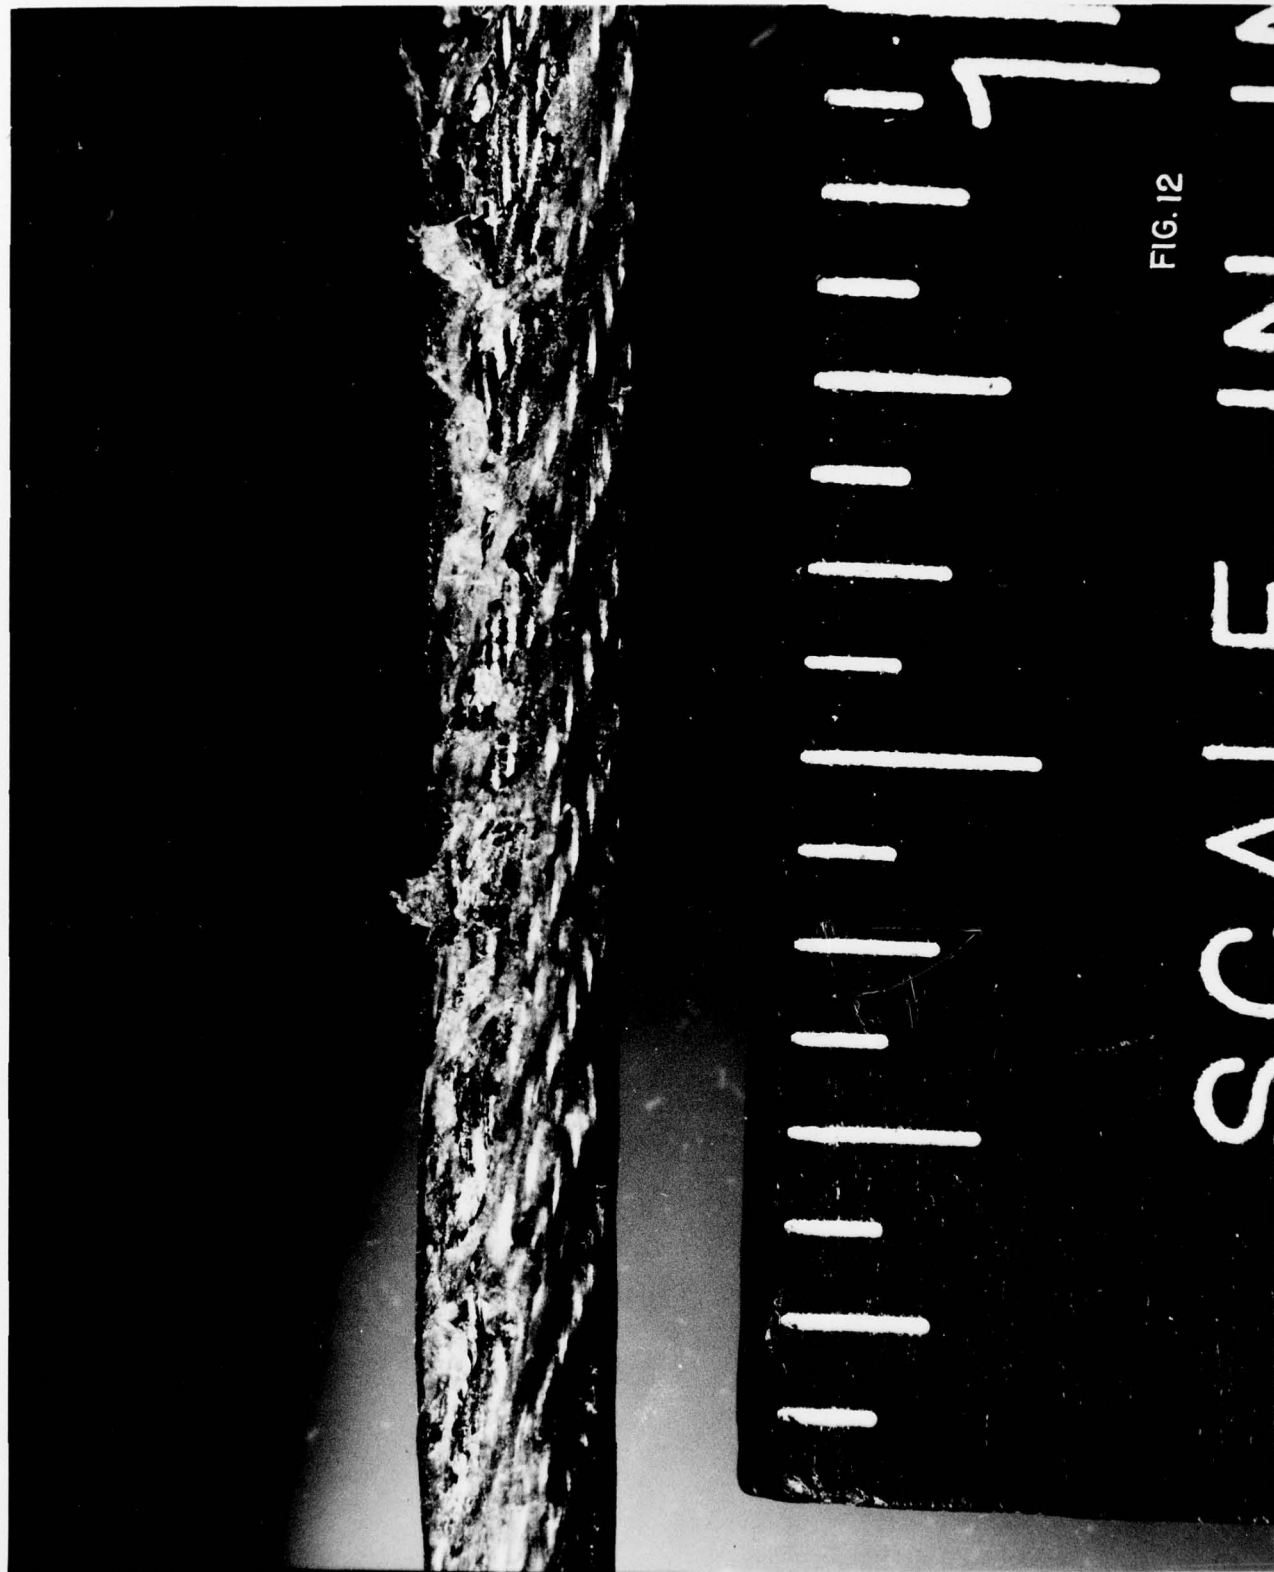
Figures 12 and 13 show the initial stage and final result of a coating failure that resulted in full separation of the coating from the wire core. The area shown was approximately 175 feet from the bathythermograph end of Cable 3. The longitudinal split of figure 12 turns into a continuous break and leads to the complete pull-away of the nylon coating and the full exposure of the wire core, as shown in figure 13. A considerable section of the wire core is exposed, making it more susceptible to corrosive attack than other sections of the wire core.

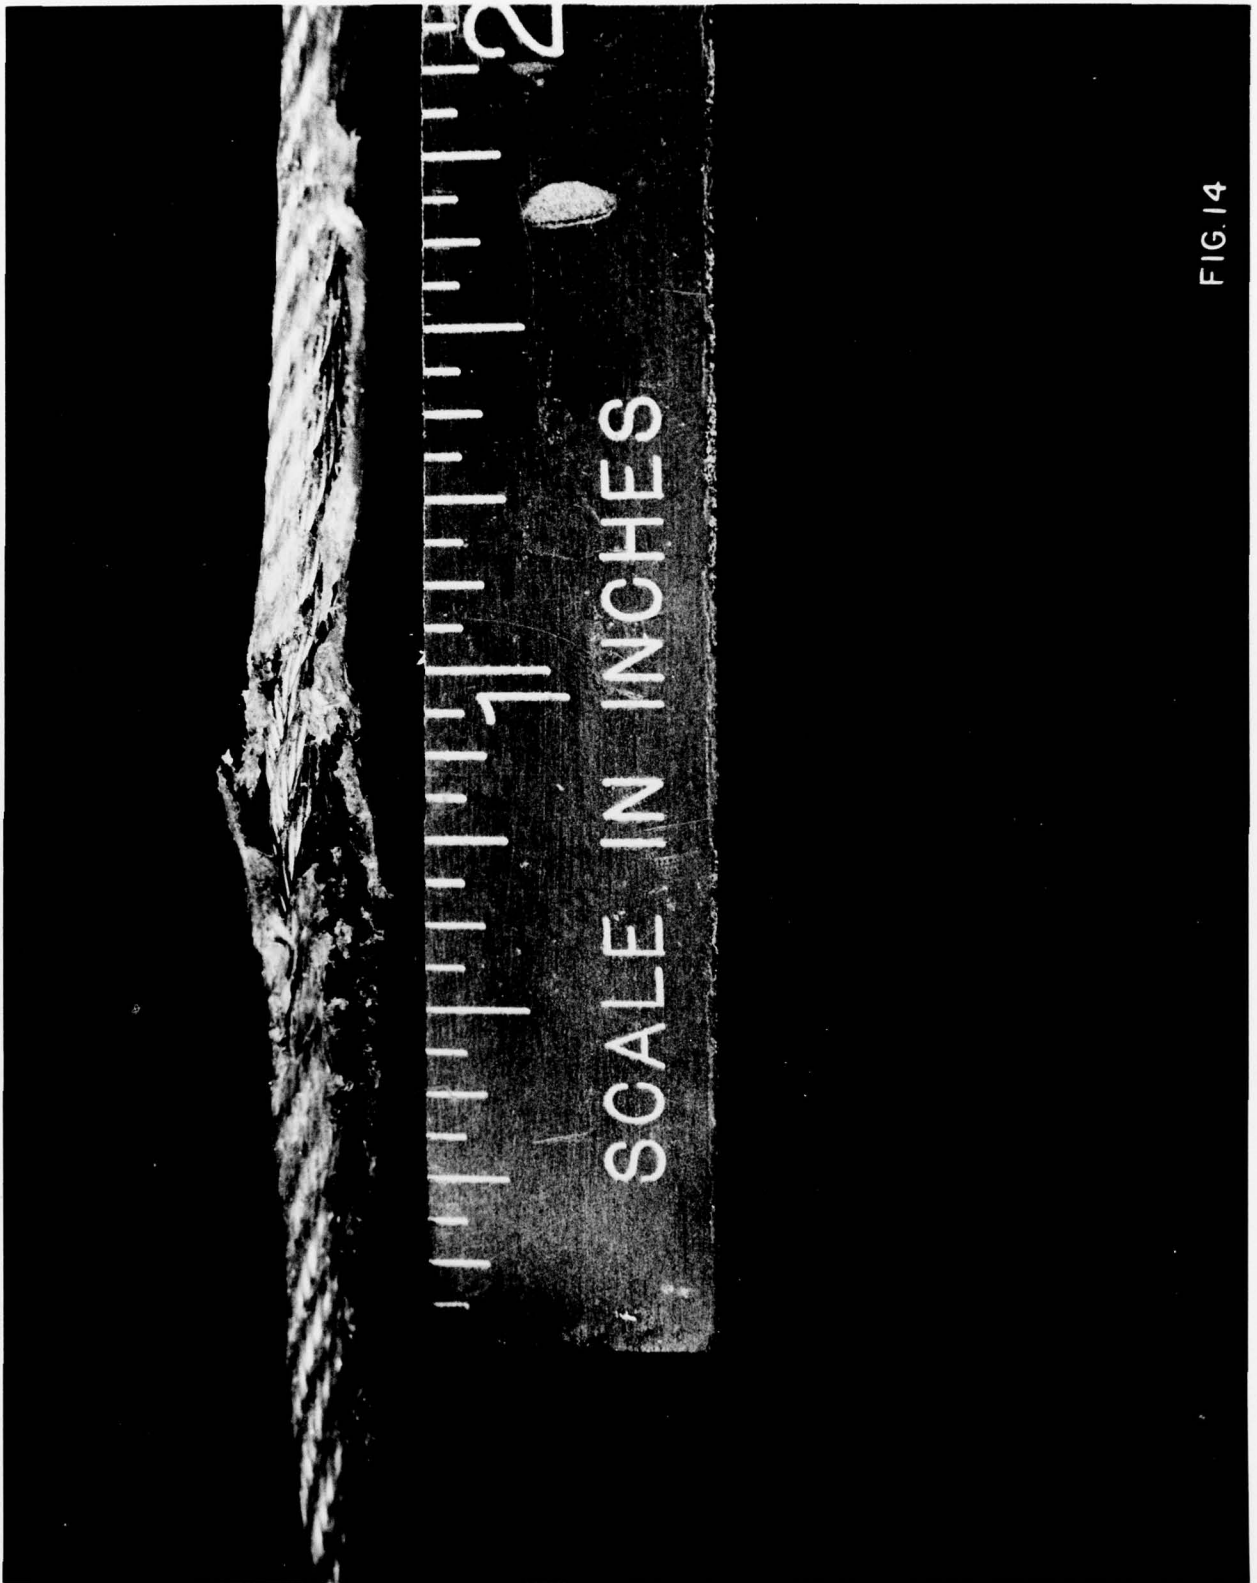
FIG. 14

figures 14, 15, and 16 are examples of the progressive stages of coating failure leading to the peeling of the 1/32-in. nylon coating from the wire core. Figure 14 illustrates an early stage of failure, where a longitudinal tear in the coating has occurred and one edge of the torn coating has started to peel from the wire core. Figures 15 and 16 show the intermediate peeling of the torn coating and, finally, the complete peeling of the coating from the wire core. This leads to a full discontinuity in the cable surface; the cable is damaged more severely as it passes through the guide sheave in this condition. Normally, a cable section with this surface condition must be cut out of the cable proper after a very small number of lowerings if it is desired to maintain the cable in service.

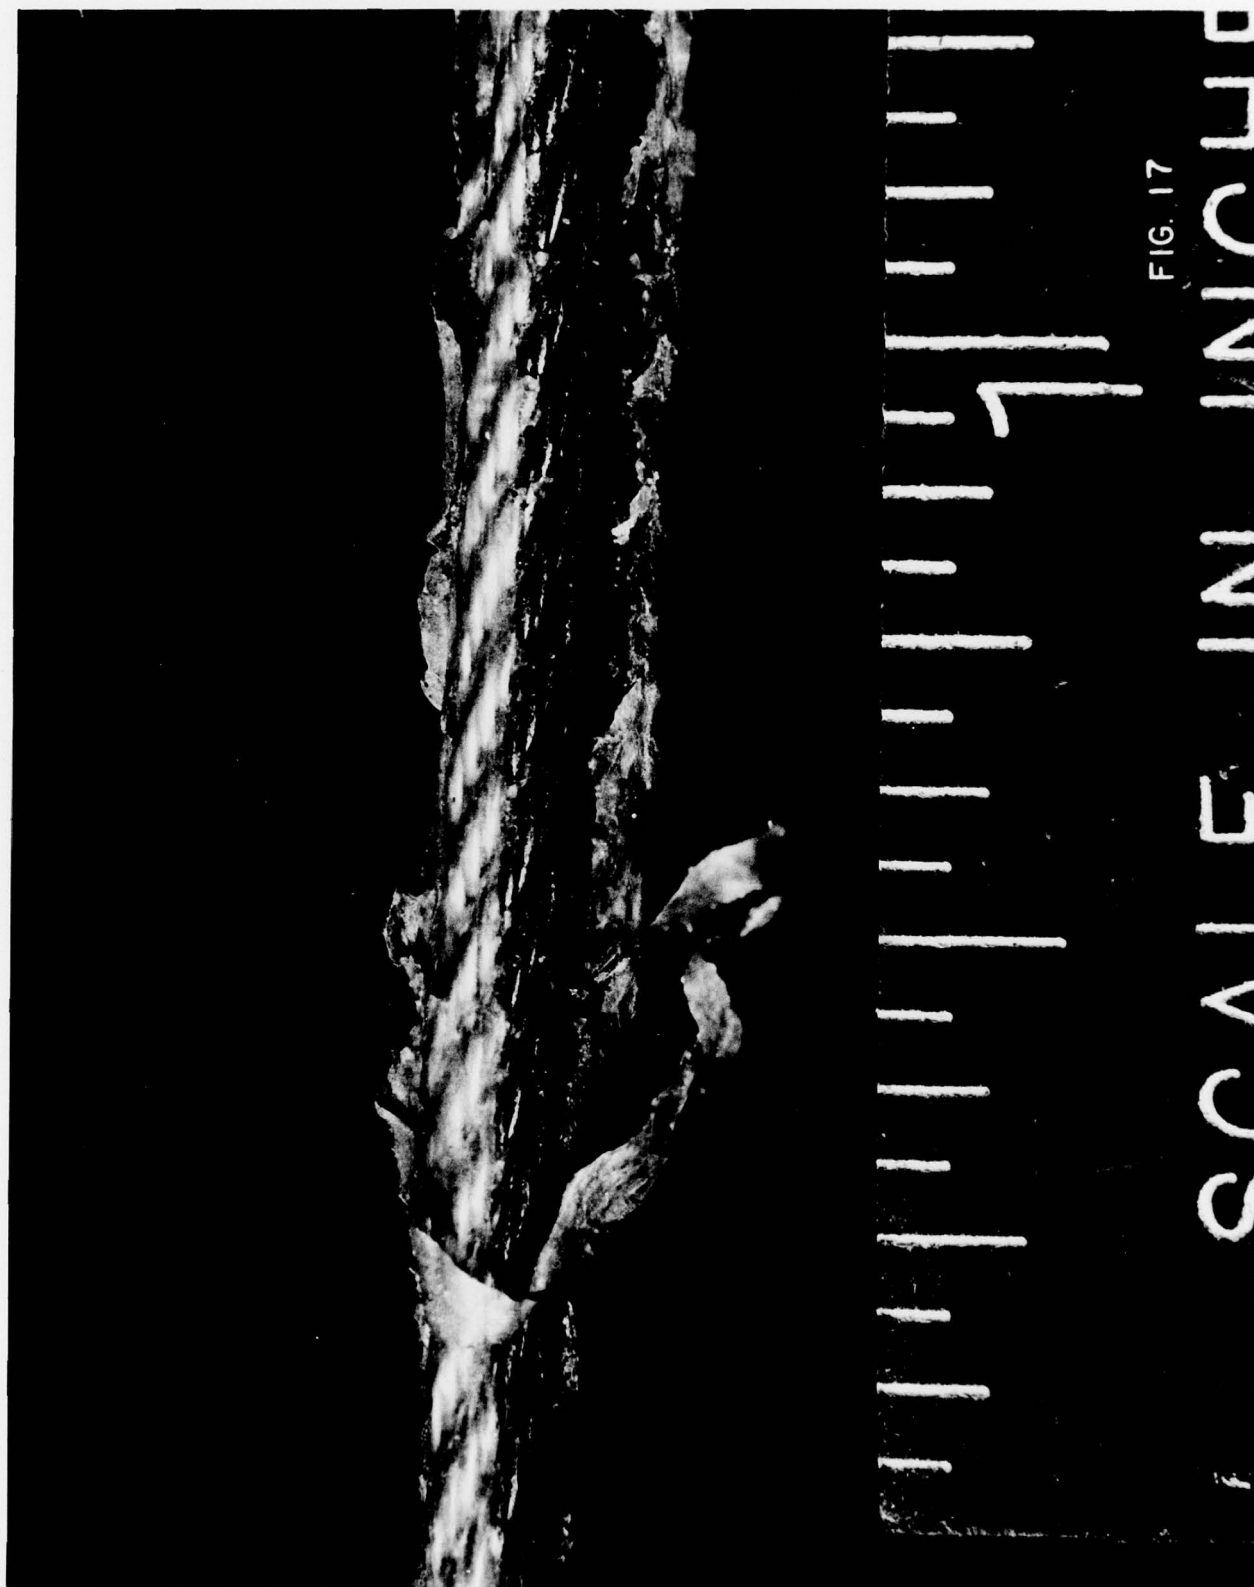
Types of coating failures restricted to a small area are shown in figures 17, 18, and 19; in most cases these failures did not lead to further damage which impaired the use of the cable. The fibrous peeling indicated in figure 17 appears to have been caused by localized abrasion and, in practically all cases, the fibrous peeling tore away from the remainder of the coating without further serious coating damage. Figure 18 shows a small, sharp transverse cut of a type which did not usually cause the coating to peel. Figure 19 is representative of a localized tear, most examples of which did not extend over 3/8 in. in length and often did not reach the wire core. All of the coating failures shown in figures 17, 18, and 19 are indicative of the generally higher durability of the 1/32-in. nylon coating as compared to the 1/64-in. coating shown in figures 1 through 13. These less severe failures occurred approximately 180 feet from the bathythermograph end of Cable 2.
